# REFURBISHMENT

# Sika MonoTop<sup>®</sup>-4400 MIC FOR MICROBIAL INDUCED CORROSION IN SEWERAGE SYSTEMS

# EXTENDING THE SERVICE LIFE AND MAINTENANCE CYCLE

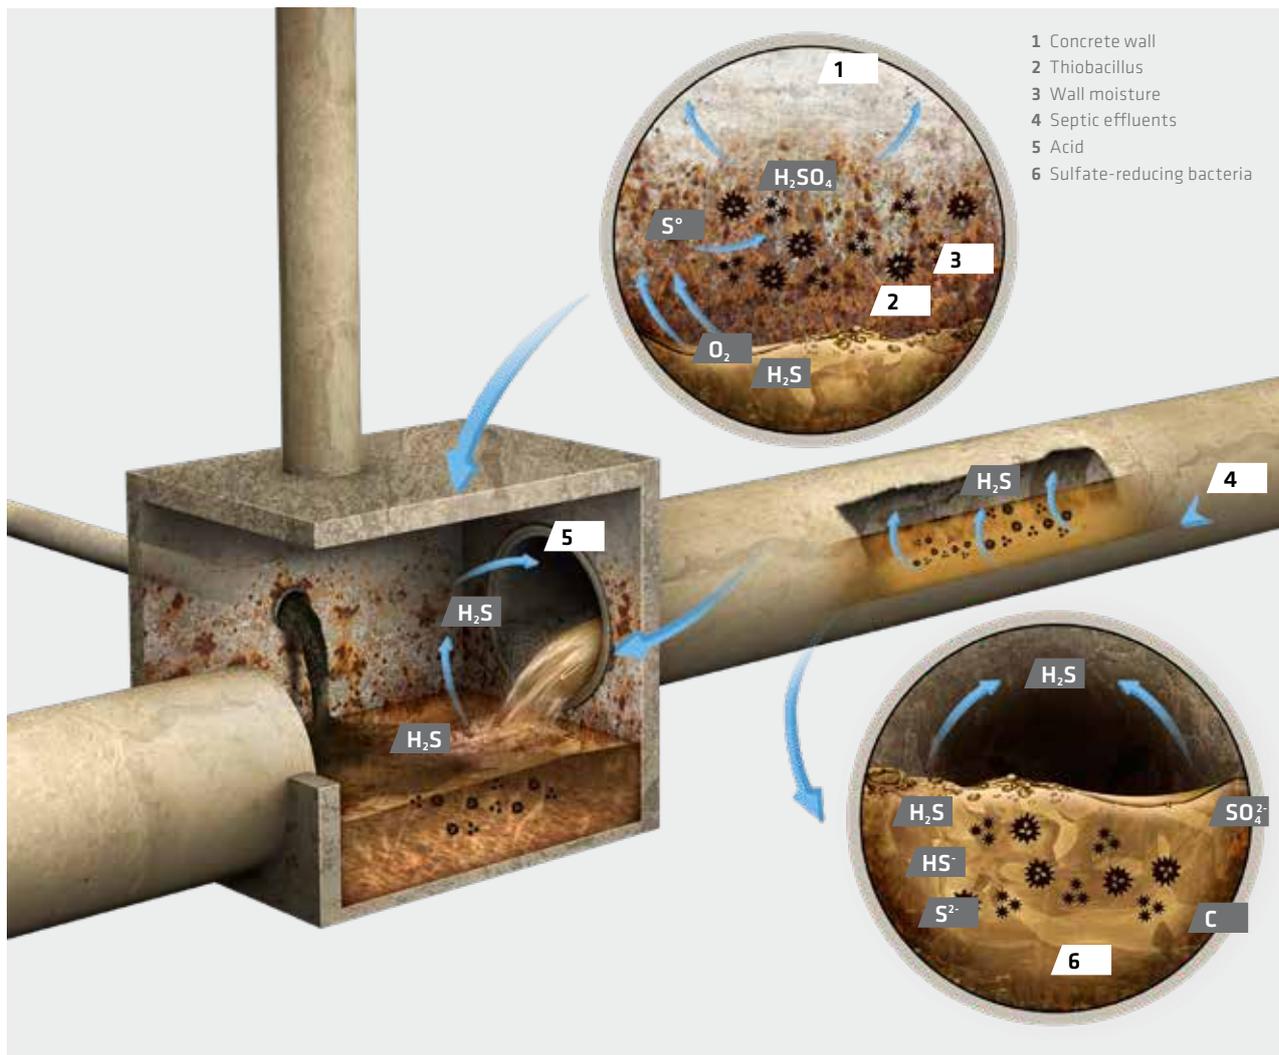
## MICROBIAL INDUCED CORROSION PRINCIPLES

Microbial induced corrosion happens when sulphates in biological waste are converted into sulphides through a biological process under the anaerobic

conditions below the waste-water line in the sewers. Above the waste-water line, the hydrogen sulphide gas that is released in this process forms aggressive and corrosive condensates with water such as sulphurous and then sulphuric acid.

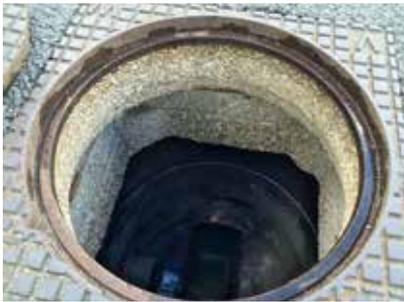
Manhole sewer entry after only 3 years in service exposed to biogenic corrosion.

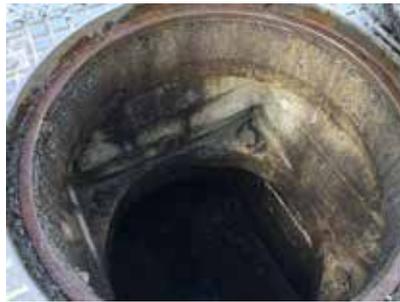
Manhole entry to storm water network after 3 years of service showing no deterioration.

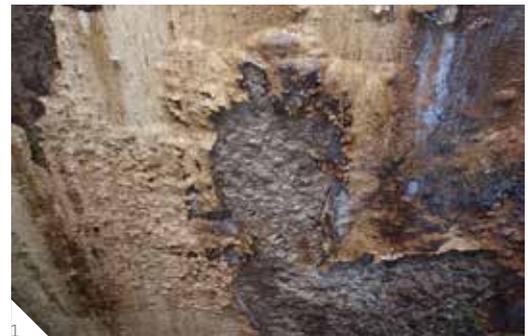
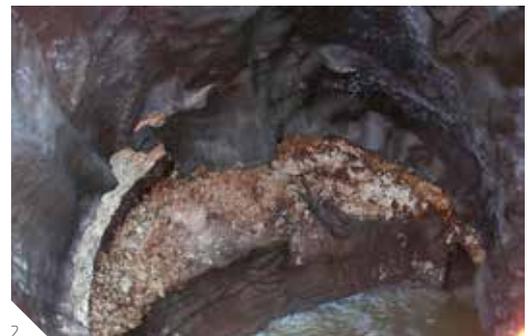
- 1 Example of polymer lining failures under H<sub>2</sub>S microbial induce corrosion conditions.
- 2 Example of polymer lining having failed to protect a mouldle from H<sub>2</sub>S corrosion.

In the past, epoxy resin coatings were used to provide some degree of additional protection against chemical attack including microbial induced corrosion, but in many situations this solution has also failed due to the extremely onerous application conditions in this environment. Many years of experience have now shown that in many situations the only reliable solution is to provide the necessary additional protection to the concrete surfaces with specially designed calcium aluminate cement based mortars.
